LEAD BASED PAINT INSPECTION AND RISK ASSESSMENT RE-EVALUATION REPORT

**Forest Service Dwelling
Corner of Osmond and Van Noy
Thayne, Wyoming 83127**

November 12, 2009

Nova Project No.: U09-1996

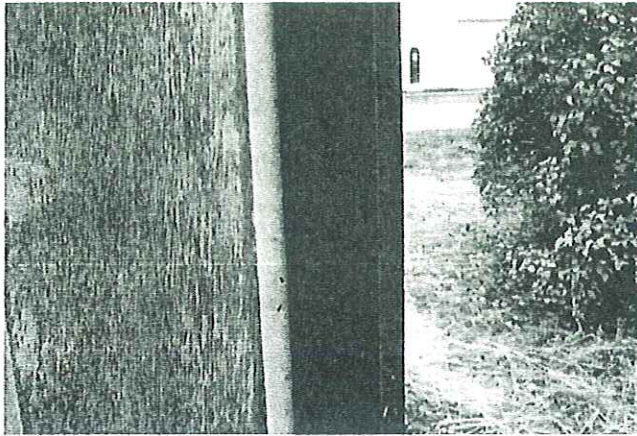
1. Green wood door jamb located in the garage

Any interior lead-based surfaces being disturbed by renovations or demolition should be conducted by a Wyoming licensed lead abatement contractor. Lead contaminated waste should be TCLP for disposal. Air and wipe clearance sampling should be conducted by a Wyoming licensed firm. Also an abatement scope of work should be produced for the removal of lead-based paint in the residence.

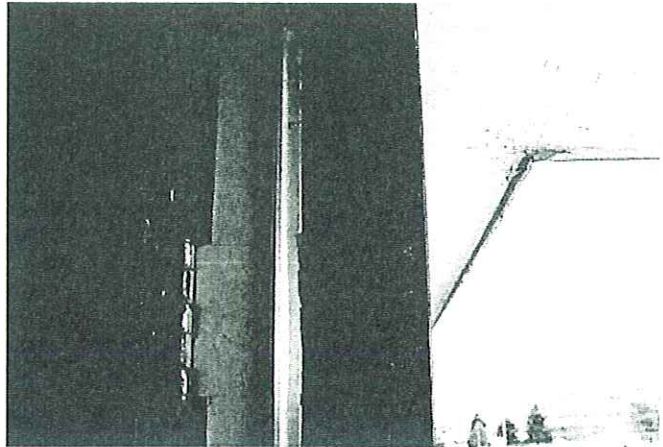
2. Green wood door jamb located in the living room

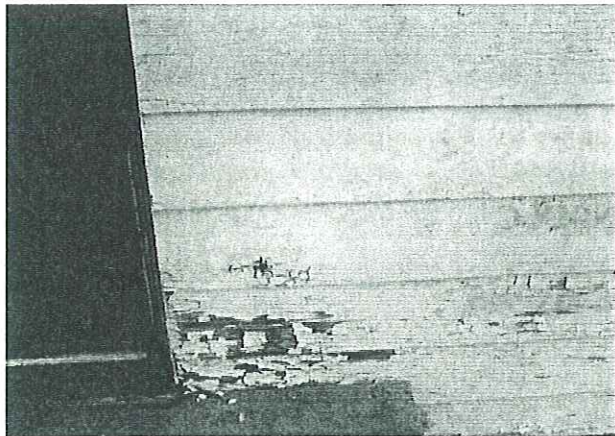
It should be noted that the lead-based paint identified on the exterior of the dwelling has changed from fair condition to poor condition and the composite soil sample went from 400 to 1,100 ppm..

1. White wood wall located on the exterior

Nova recommends that due to the increased levels of the lead paint in the soil, the exterior paint on the wood walls, windows, trim, and soffits should be removed by a State of Wyoming licensed contractor.

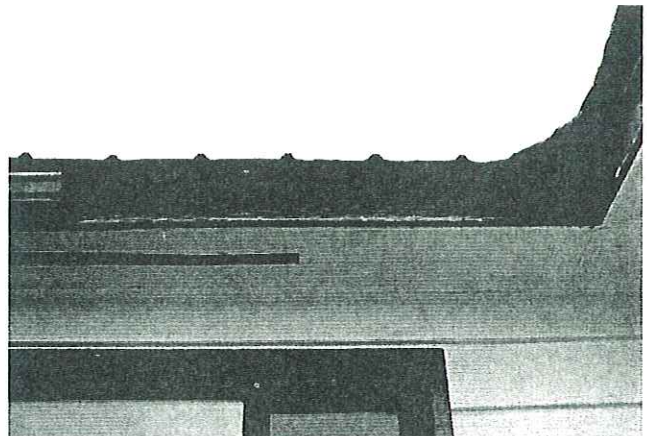
2. Green wood trim and white soffit located on the exterior

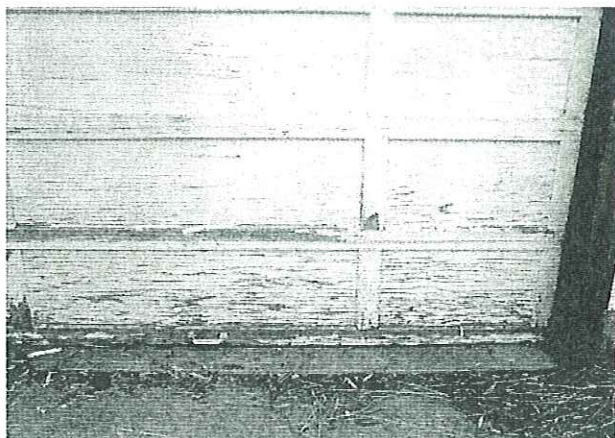
1. White wood garage door located on the exterior

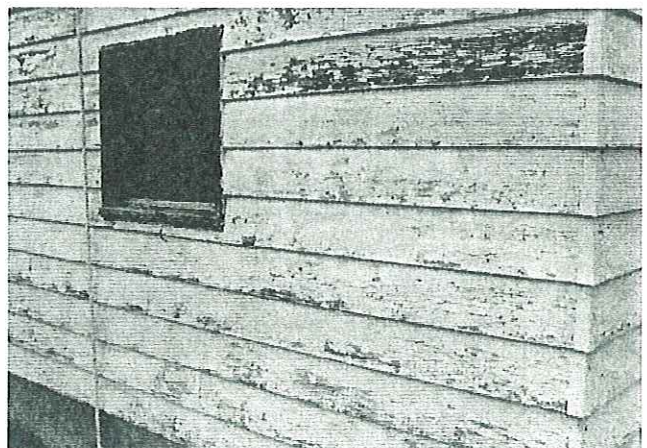
2. White wood wall located on the exterior
